Inspection Report

Property Address:
12712 Waterside Drive
Alpharetta, GA 30004

Atlanta Home Inspections

Date: 11/12/2012	Time: 10:30 AM	Report ID: sample111212
Property: 12712 Waterside Drive Alpharetta, GA 30004	Customer: Sampath Sample	Real Estate Professional:

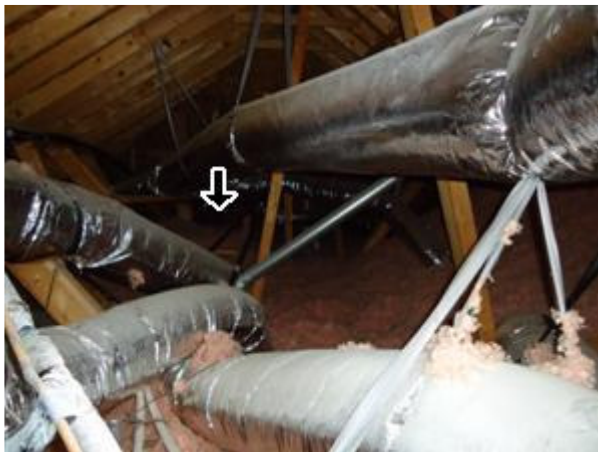
1.5 Picture 1

(1) Attic access was limited. I did not inspect all the areas of the attic. This is for your information.

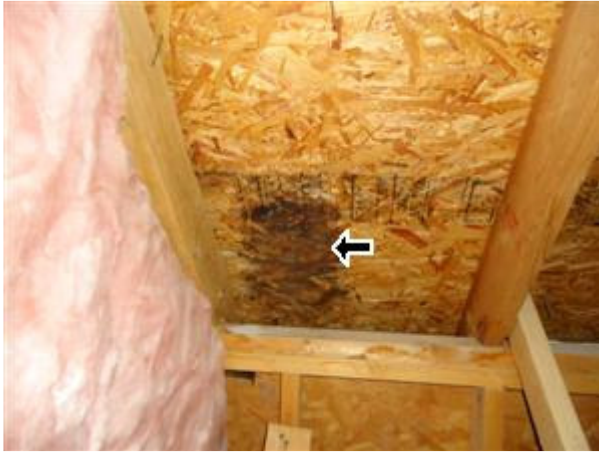
1.5 Picture 2

(2) Roof sheathing has water stains from what appears to be a small leak. Further damage from moisture can occur if not corrected. Recommend repair by a qualified roofing contractor.

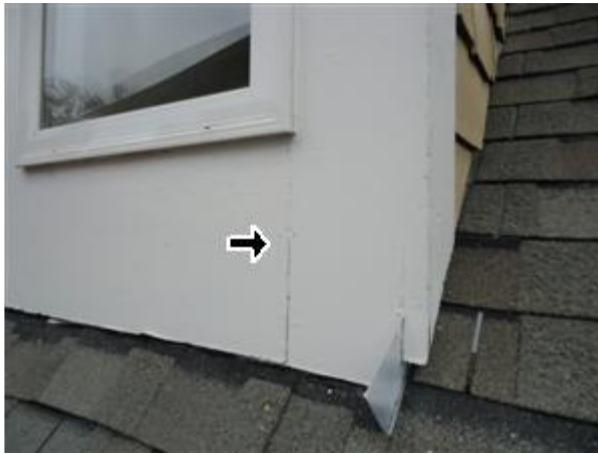
2.0 Picture 1

(1) Wall cladding sealant is showing signs of deterioration at various areas around the home. Damage from moisture can occur if not sealed/maintained properly. Recommend repair by a qualified contractor.

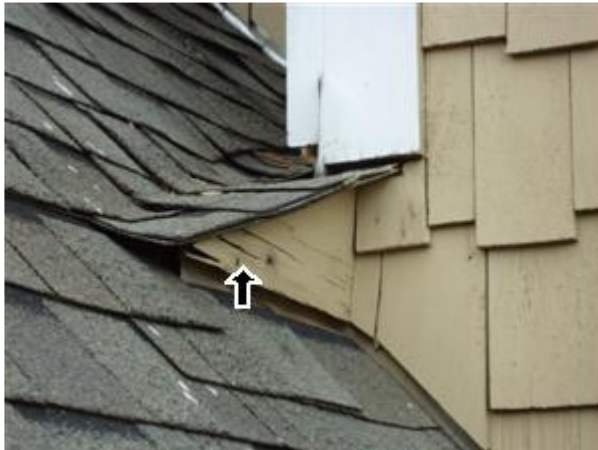
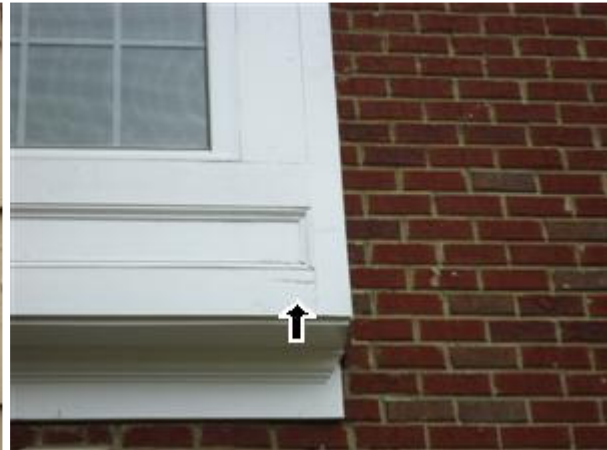
(2) Wood siding is damaged/deteriorated at front of home. Further damage to the siding, and possibly the framing can occur from moisture if not corrected. Recommend repair or replace by a qualified contractor.

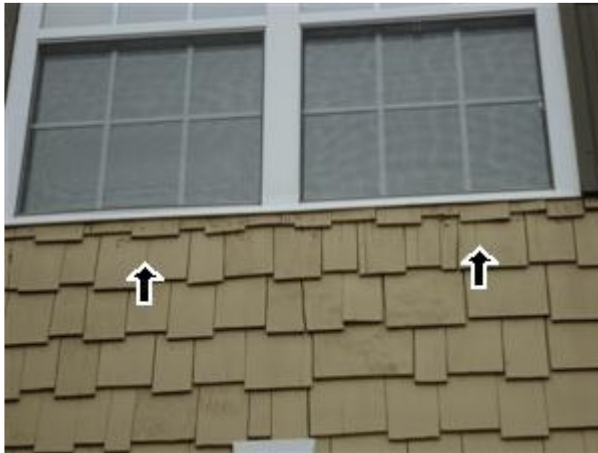
2.0 Picture 4

(3) Wood siding has a series of nail holes that have not been filled. Further damage to the siding, and possibly the framing can occur from moisture if not corrected. Recommend repairs by a qualified contractor.

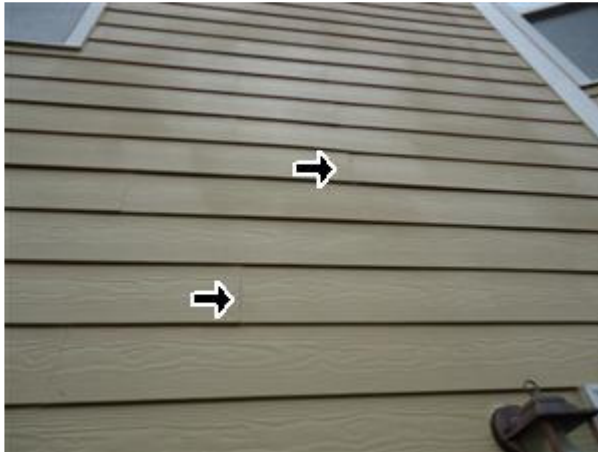
2.0 Picture 5

(4) Cement board siding at various areas around the home needs sealant at joints. Damage from moisture can occur if not sealed properly. Recommend repair by a qualified contractor.

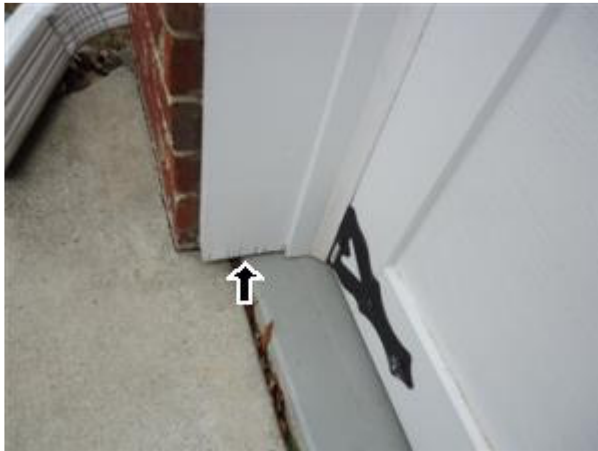
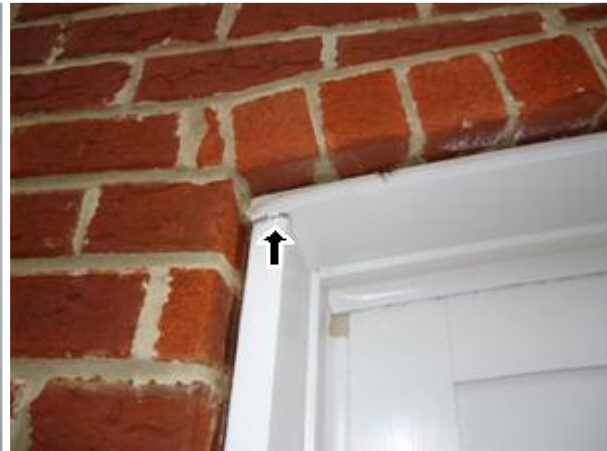
(1) Garage door casings show signs of deterioration at front of home. Moisture can cause further deterioration, and possibly damage the framing if not corrected. Recommend repair by a qualified contractor.

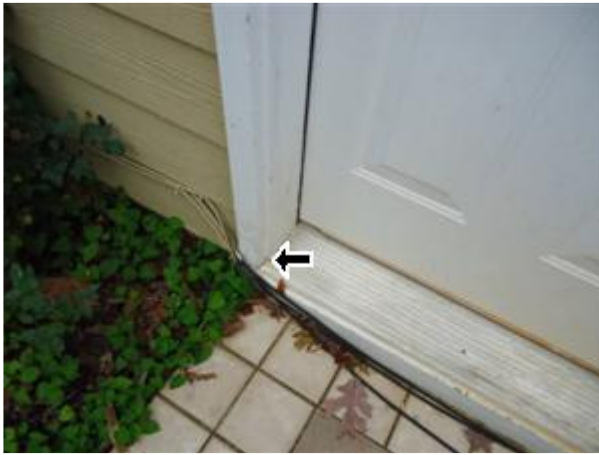
2.1 Picture 3

(2) Exterior door at rear of home is deteriorated at brick mouldings, and jambs. Further deterioration can occur from moisture if not corrected. Recommend repair by a qualified contractor.

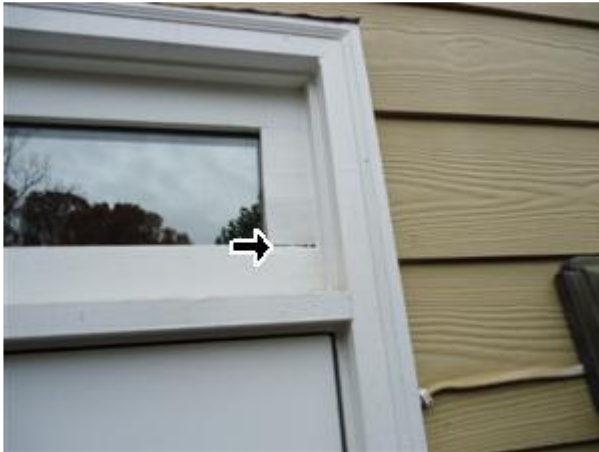
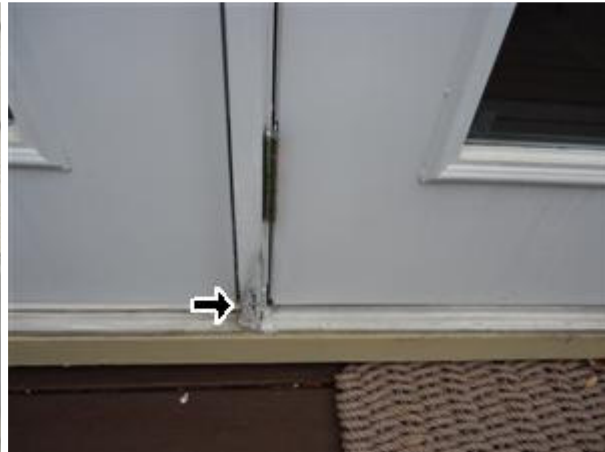
(3) Exterior door at rear of home is deteriorated at mouldings. Further deterioration can occur from moisture if not corrected. Recommend repair by a qualified contractor.

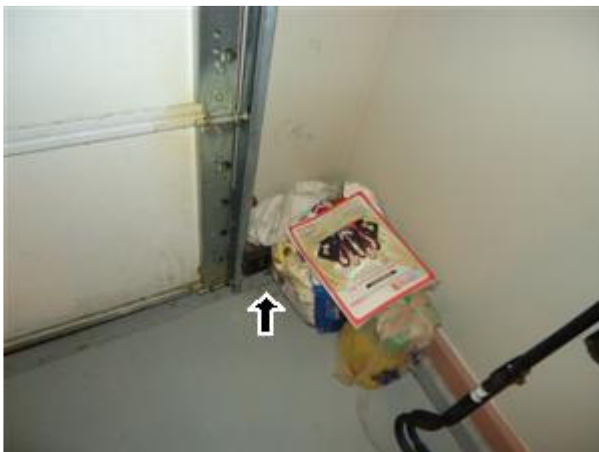
2.3 Picture 1

Garage door safety sensor did not work for one door when tested. This is a potential safety issue. Recommend repair by a qualified garage door contractor.

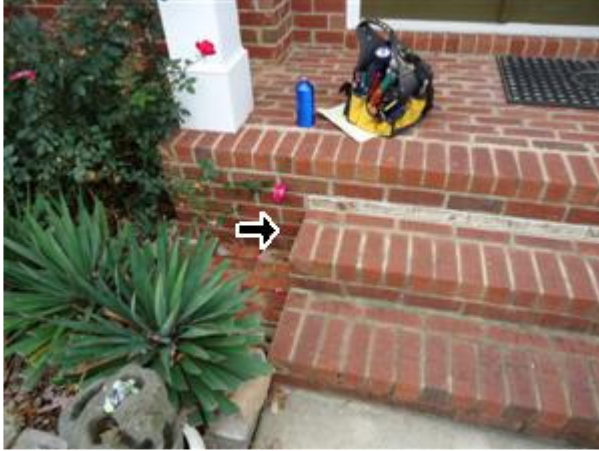
2.4 Picture 1

(1) Hand rails for stairs are missing at front of home. A fall or injury can occur if not corrected. Recommend repair by a qualified contractor.

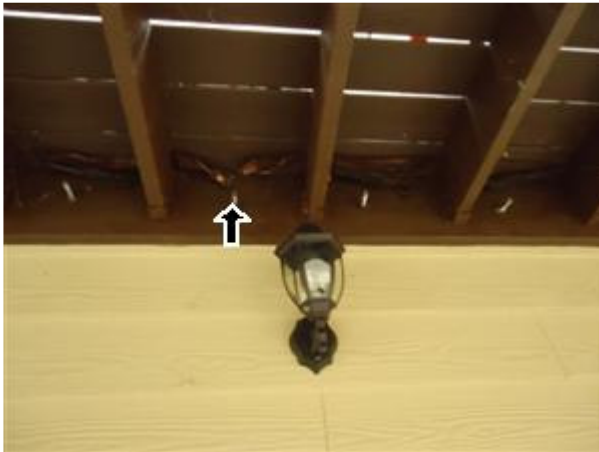
2.4 Picture 2

(2) Deck ledger flashing is damaged at rear of home. Flashing prevents water from entering behind this area. Further damage from moisture can occur if not corrected. Recommend repair by a qualified contractor.

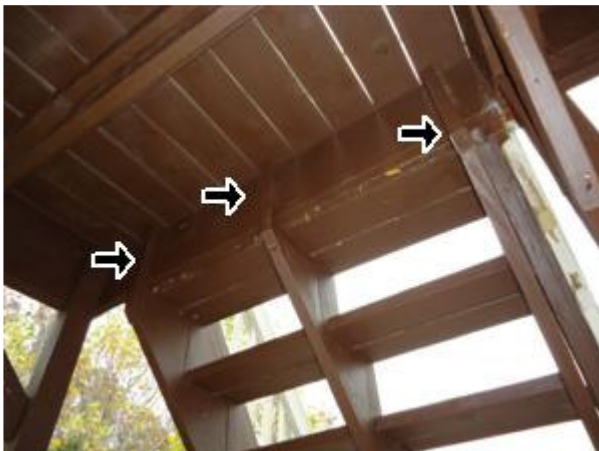
2.4 Picture 3

(3) Deck stair system at rear of home is not supported properly and is a safety concern. This is a structural support issue that needs to be corrected. Recommend repairs by a qualified contractor.

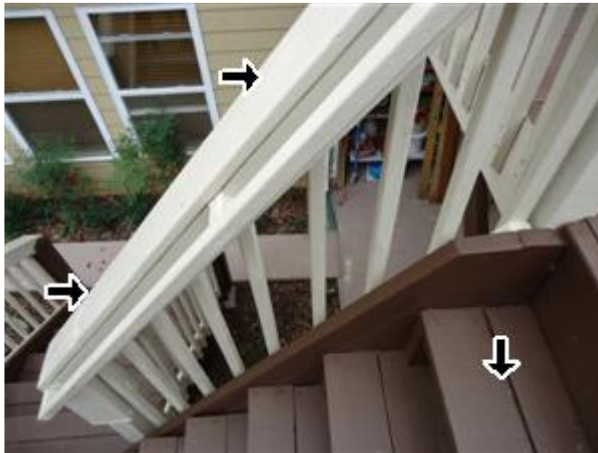
2.4 Picture 4

(4) Stair handrails are not cut to proper heights and stair treads are cut at a steep angle . This is a potential safety issue and a fall or injury can occur if not corrected. Recommend repair by a qualified contractor.

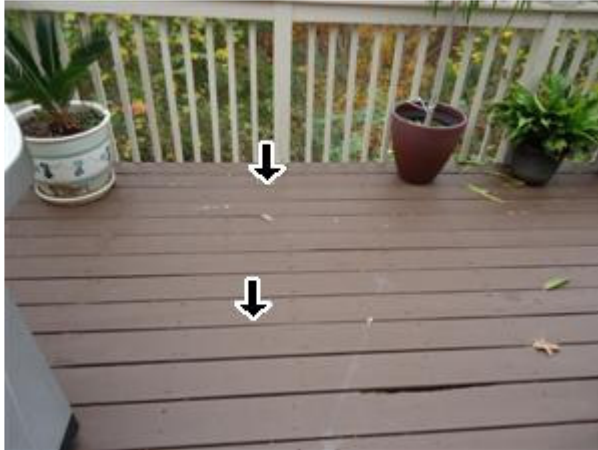
2.4 Picture 5

(5) Deck addition shows signs of settlement at rear of home. This is a potential safety issue. Recommend a structural engineer to evaluate this structure and repair as necessary.

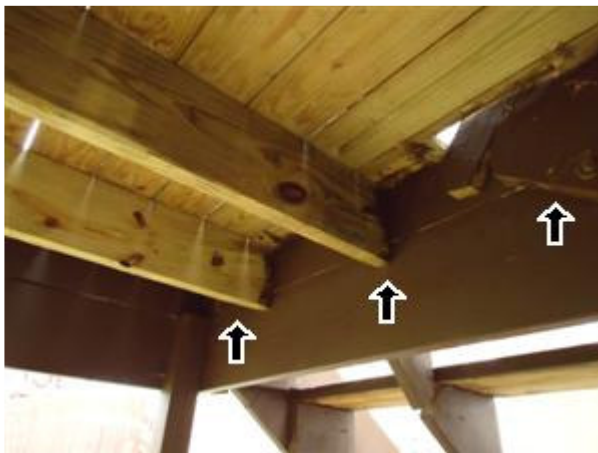
2.4 Picture 6

(6) Joist supports are missing at stair landing. This is a structural support issue that needs to be corrected. Recommend repair by a qualified contractor.

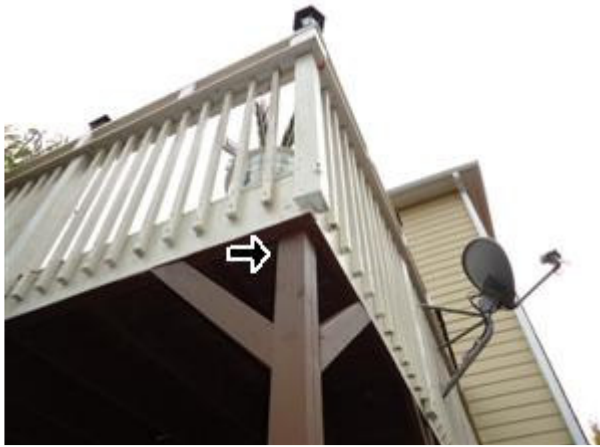
2.4 Picture 7

(7) Post supports for deck addition are not supporting the deck properly. Supports should be installed under the outer band for proper support. This is a potential safety issue. Recommend repairs by a qualified contractor.

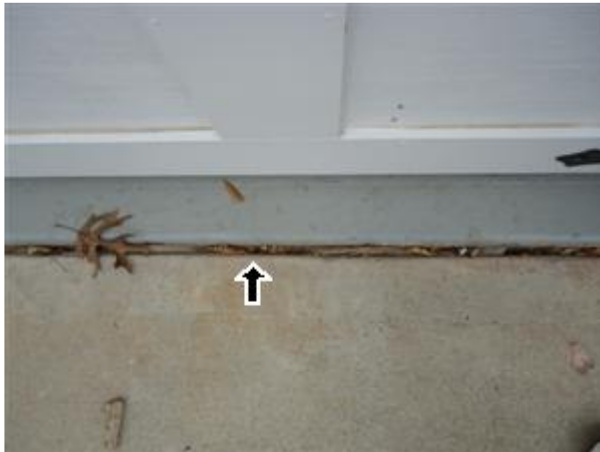
2.5 Picture 1

(1) Wood for boards were never removed at front of home. Building materials can absorb moisture attracting wood destroying insects. Recommend a qualified contractor to remove what is left of wood material and seal cracks.

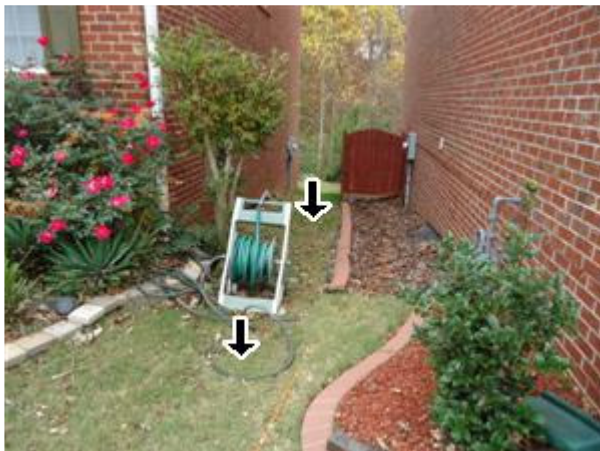
2.5 Picture 2

(2) Surface erosion is occurring at right side of home facing front. If erosion continues to occur harmful water penetration to the foundation can occur. Recommend repair by a qualified landscape contractor.

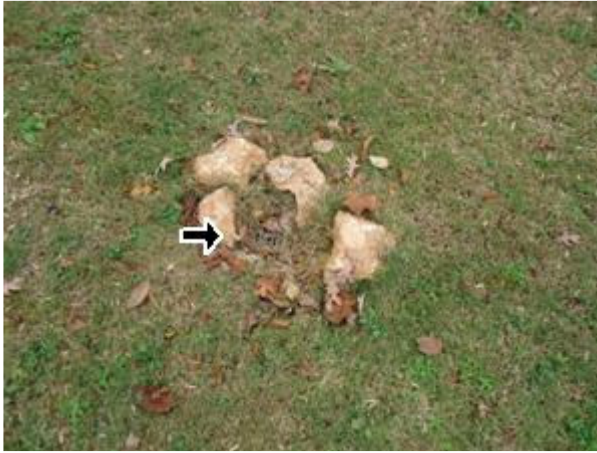
2.5 Picture 3

(3) Landscape drain is clogged with debris at rear of home. Clogged drains can cause water to pool and erosion can occur. Recommend further evaluation and repairs by a qualified landscape contractor.

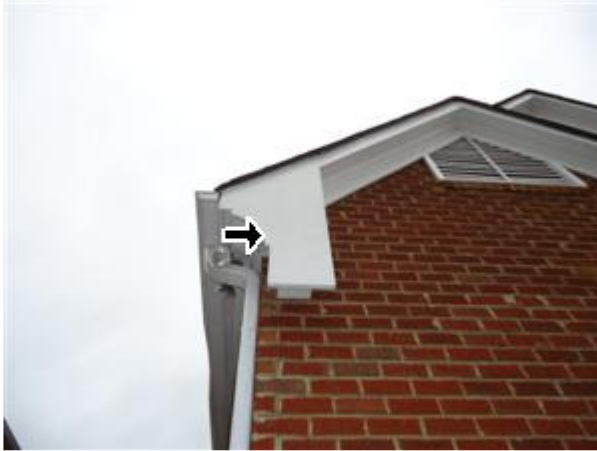
2.6 Picture 1

Wood fascia/soffit are showing signs of deterioration at various areas around the home. Further damage from moisture can occur if not maintained/sealed properly. Recommend qualified contractor to repair or replace.

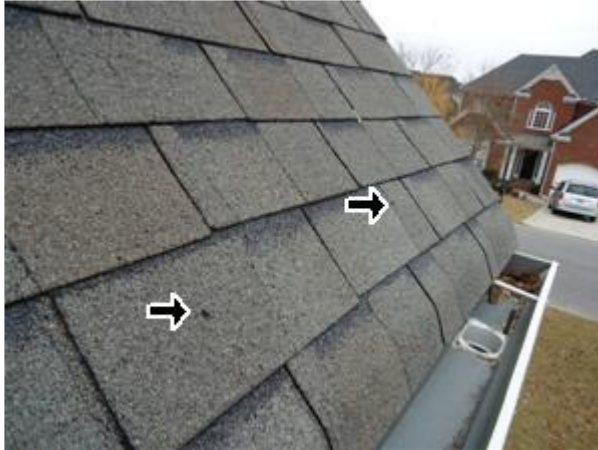
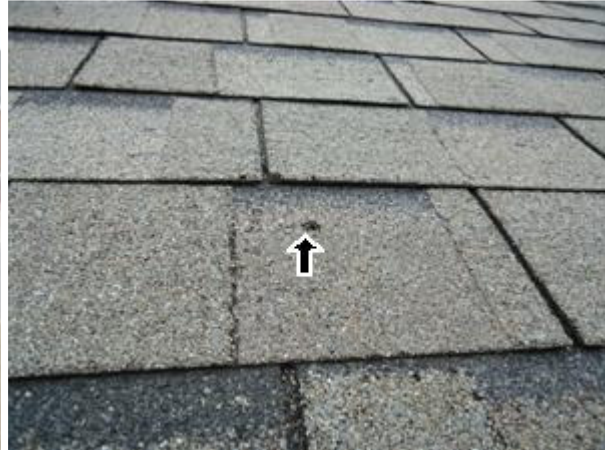
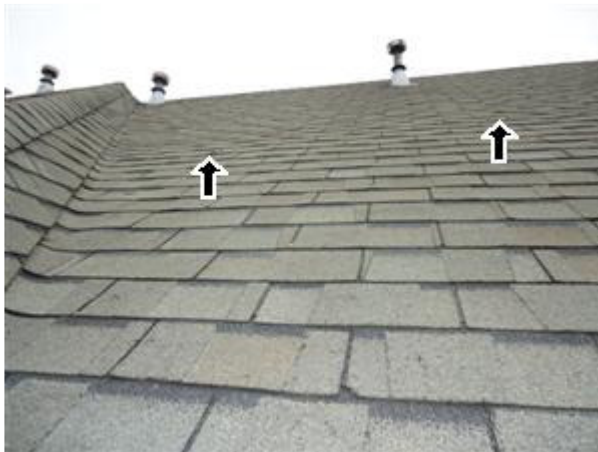
(1) Problems discovered at roof covering such as nail holes, exposed nails, and any other issue that a qualified roofing contractor may find while making repairs. These areas can leak if not corrected. Recommend a qualified roofing contractor to go over the whole roof and make necessary repairs.

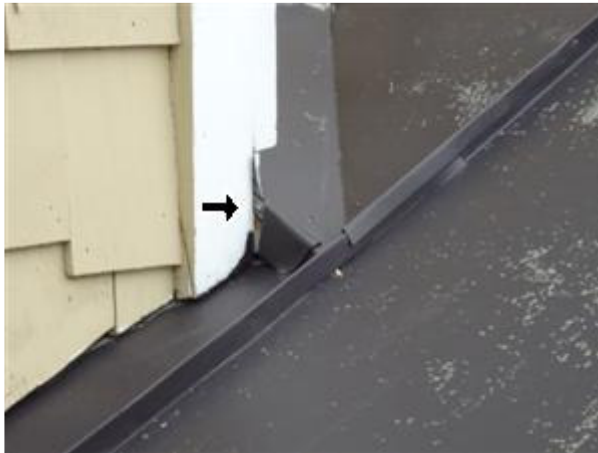
3.0 Picture 4

(2) Wood framing is exposed at front of home. Further damage can occur from moisture if not corrected. Recommend repair by a qualified roofing contractor

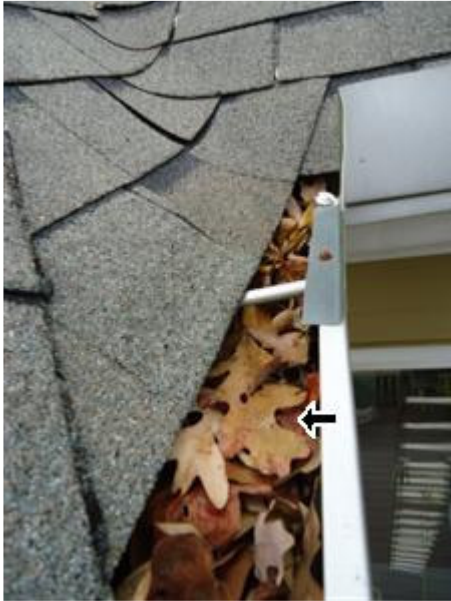
3.3 Picture 1

Gutter is clogged at rear of home Clogged gutters can cause deterioration of the fascia, soffit, and roof edge if not corrected. Recommend repair by a qualified contractor.

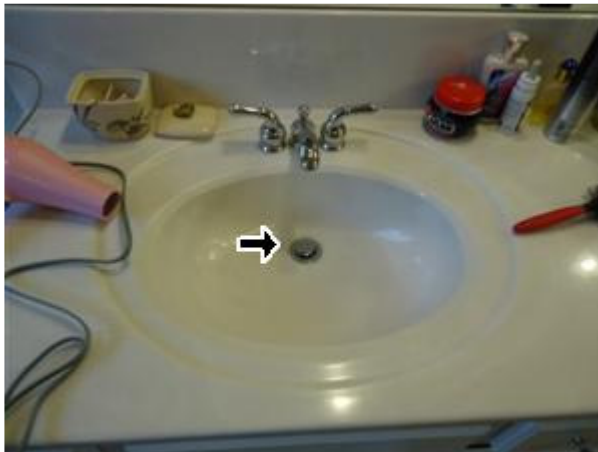
4.0 Picture 1

(1) Plumbing waste line drains slowly at master bathroom. The drain may be clogged at the valve, or possibly down line. Recommend repair by a qualified plumber.

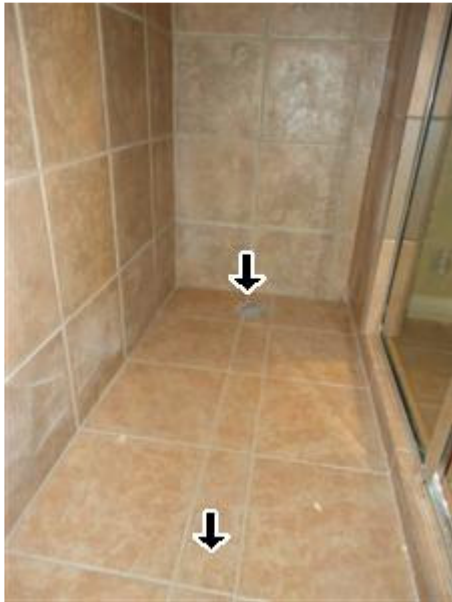
4.0 Picture 2

(2) Shower floor appears to have very little pitch to drain water properly at basement bathroom. I was unable to determine if this area would drain water due to the water supply being cut off. Recommend a licensed plumber to inspect this drain and also check for proper shower pan liner installation.

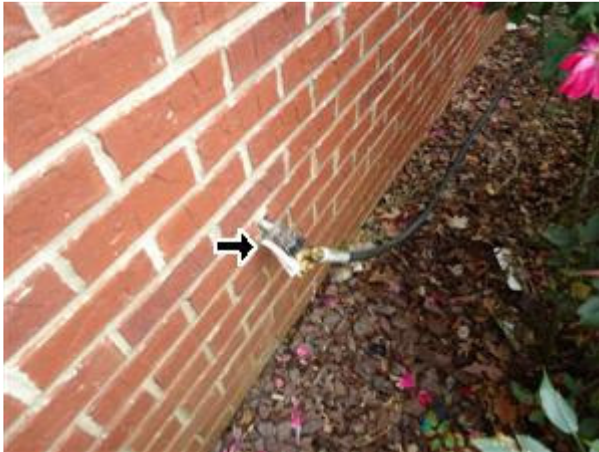
4.1 Picture 1

(1) Outside water faucet was not secured properly and handle is broken. Supply lines could break if not corrected. Recommend repairs by a licensed plumber.

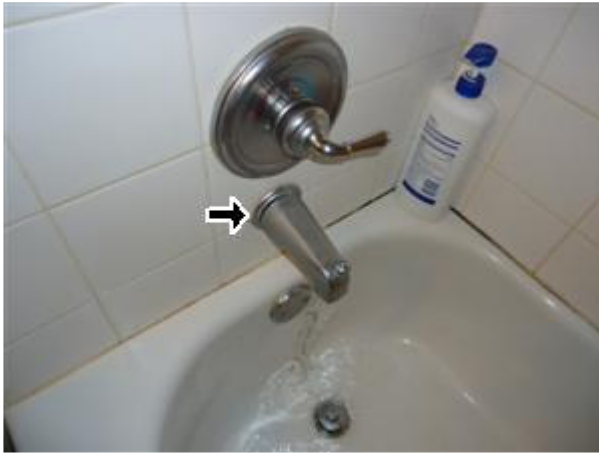
4.1 Picture 2

(2) Shower tub faucet has pulled loose from the wall at guest bathroom. Further damage can occur from water entering behind this area. Recommend repair by a licensed plumber.

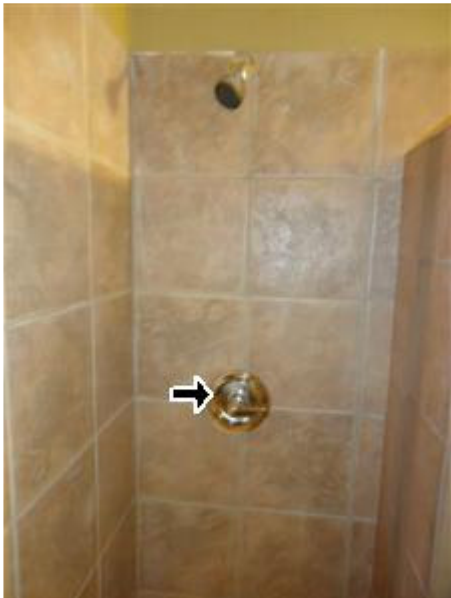
4.1 Picture 3

(3) Shower fixture at basement bathroom did not function at the time of inspection. I did not inspect this item.

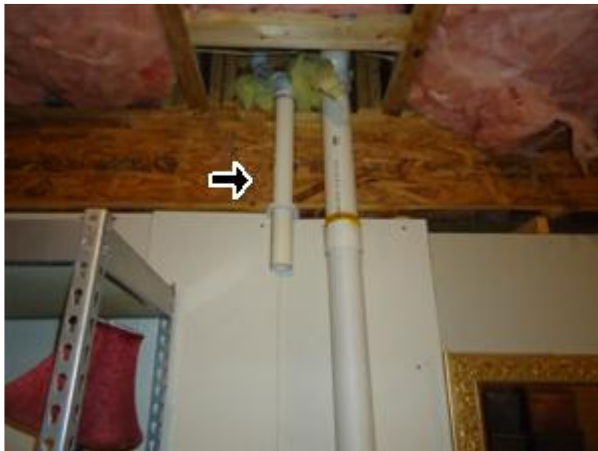
4.5 Picture 1

(1) Sump pump exhaust vent is not connected to the unit. Waste water will not be able to discharge properly and possibly cause damage to the home. Recommend a licensed plumber for further evaluation and repairs.

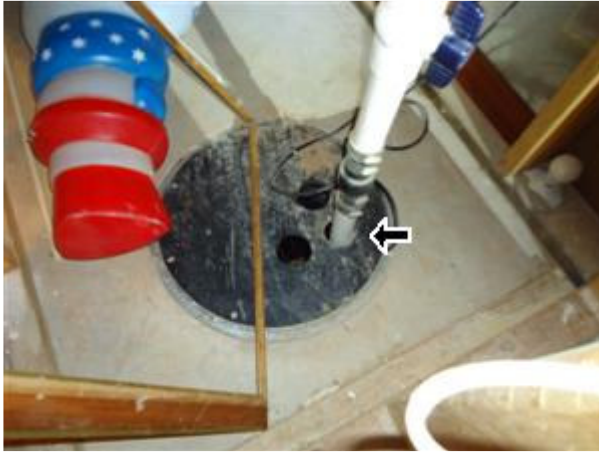
4.5 Picture 2

(2) Sump pump discharge line is not properly sized. Damage to house hold components can occur if not corrected. Recommend a licensed plumber for repairs.

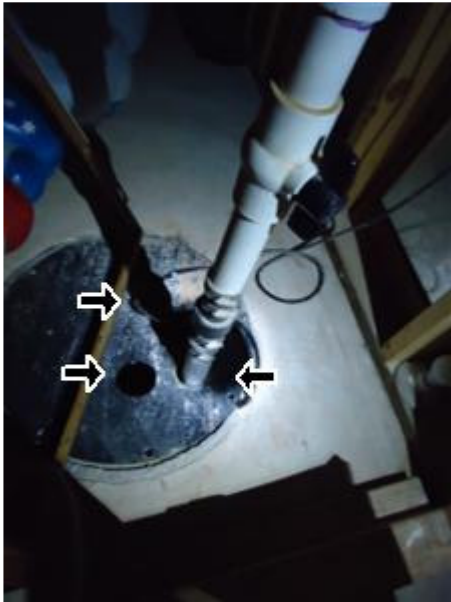
4.5 Picture 3

(3) Sump pump basing is not sealed properly. Sewer gases can vent into the basement and is a potential health concern. Recommend repairs by a licensed plumber.

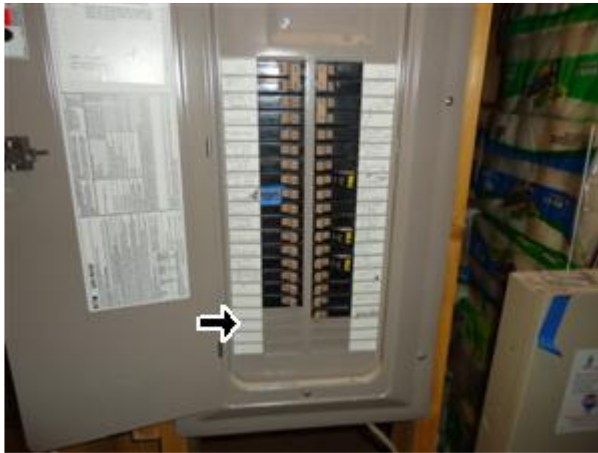
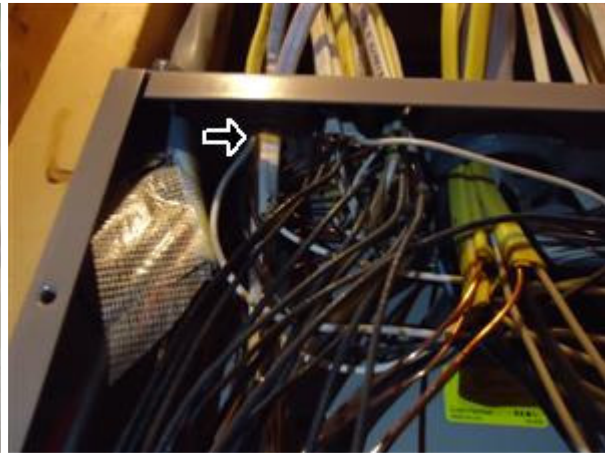
Problem(s) discovered in main electrical panel such as breakers not labeled properly, missing romex wire protector, and any other problems that a electrician may discover while performing repairs that need correcting. Recommend a licensed electrician inspect for all repairs.

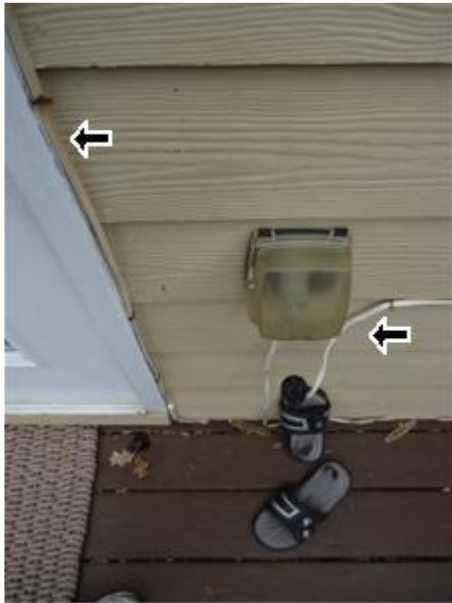
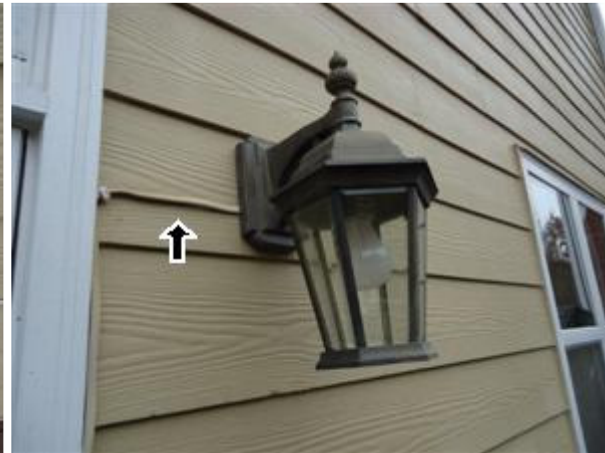
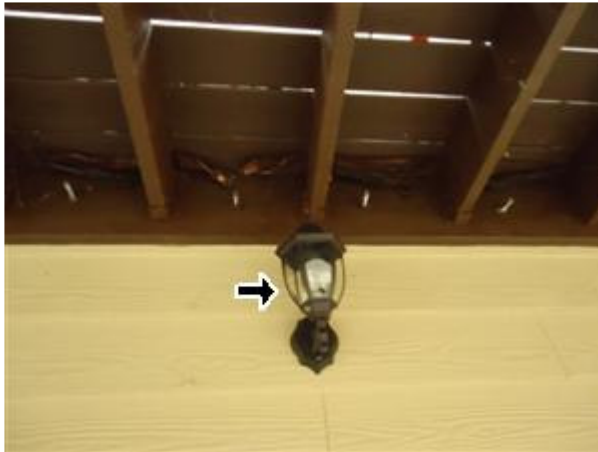
(1) Electrical wiring is exposed to exterior elements and does not appear to be wired properly at rear of home. This is a safety issue that needs to be corrected. Recommend repairs by a licensed electrician when wiring is involved.

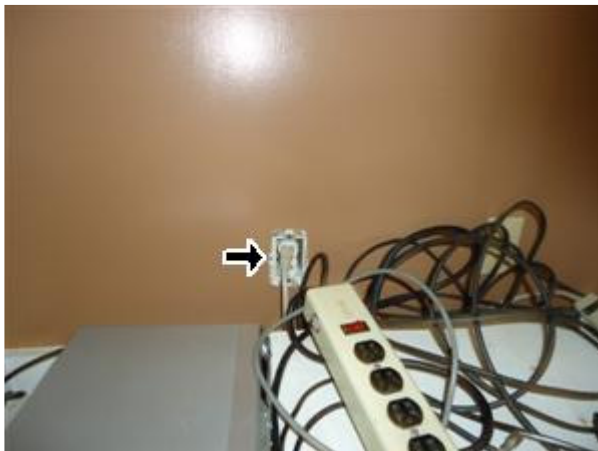
5.3 Picture 4

(2) Three prong outlet is missing its cover plate at living room. This is a safety issue that should be corrected. Recommend repair by a licensed electrician when any wiring is involved.

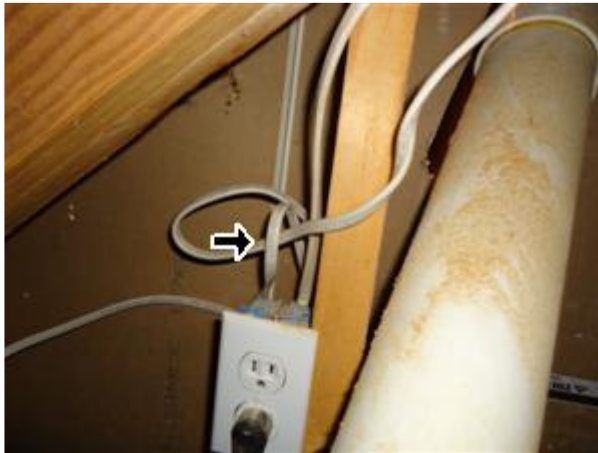
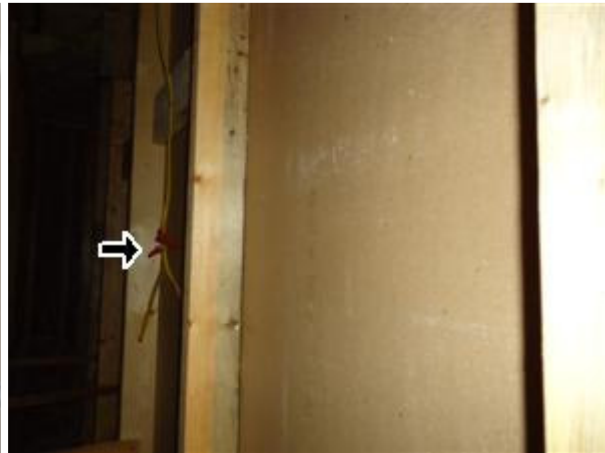
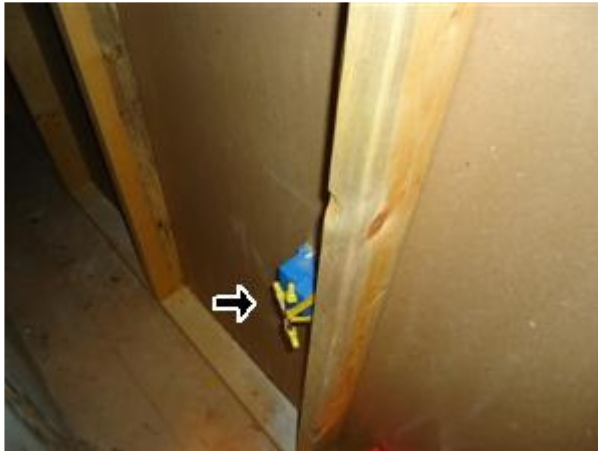
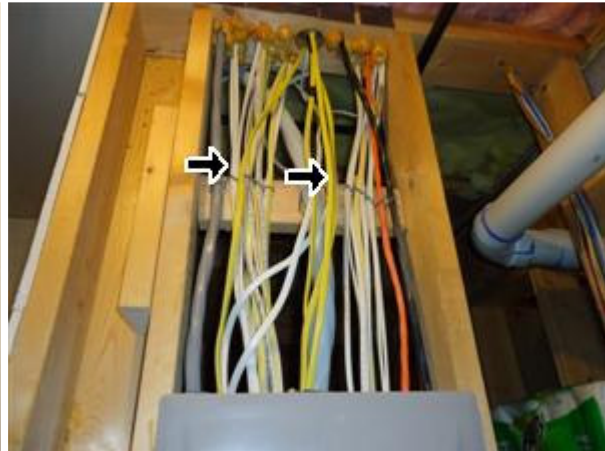
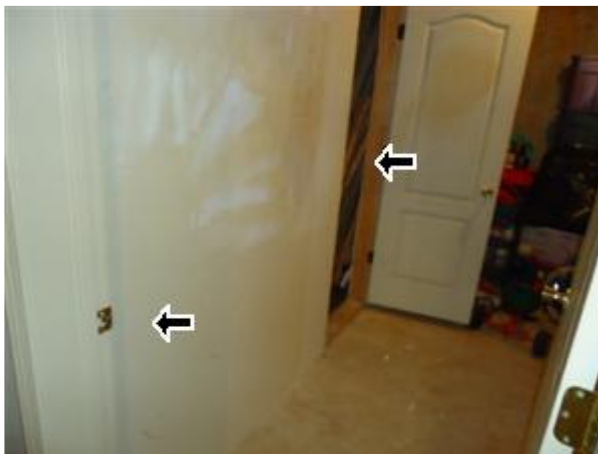
(3) Problems discovered with basement electrical wiring such as exposed wiring behind finished walls, wiring not secured properly, and missing electrical switches at unfinished areas. These are all potential safety issues and some fire safety issue that need repair. Recommend further inspection and repairs by a licensed electrician.

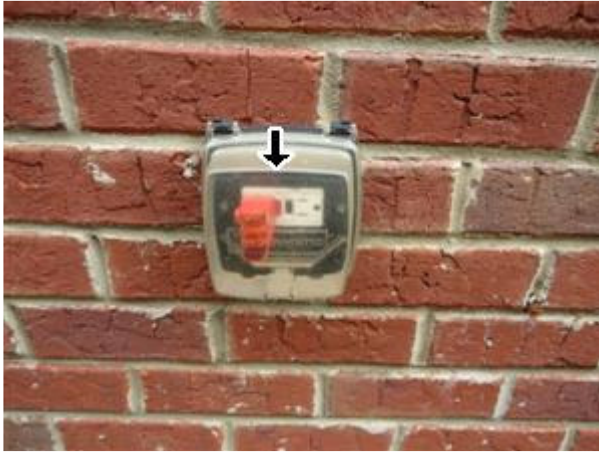
5.5 Picture 1

GFCI outlet did not work when tested at left side of home facing front. This is a safety issue. Recommend repairs by a licensed electrician.

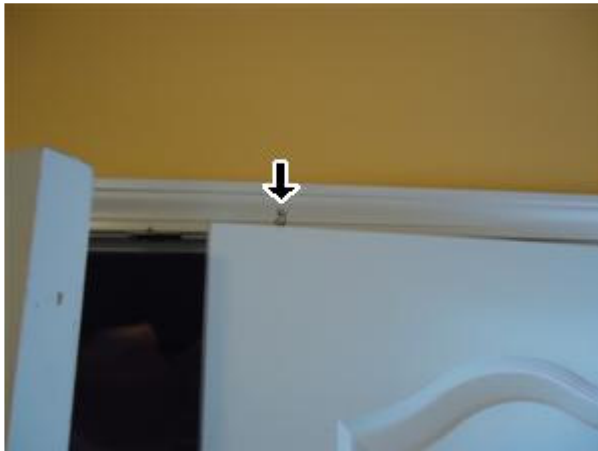
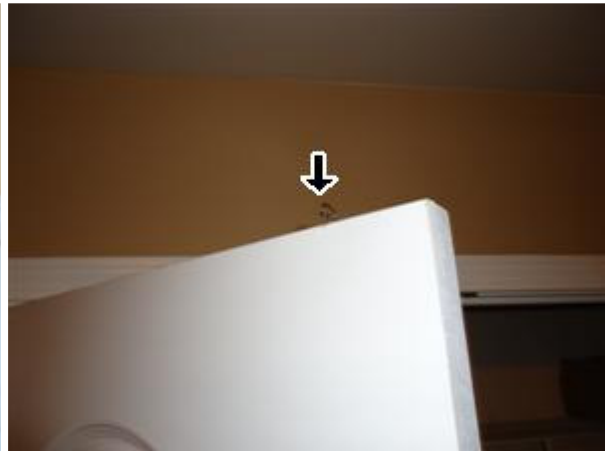
(1) Closet door catch balls are missing. Further damage to the door casing can occur if not corrected. Recommend repair by a qualified contractor.

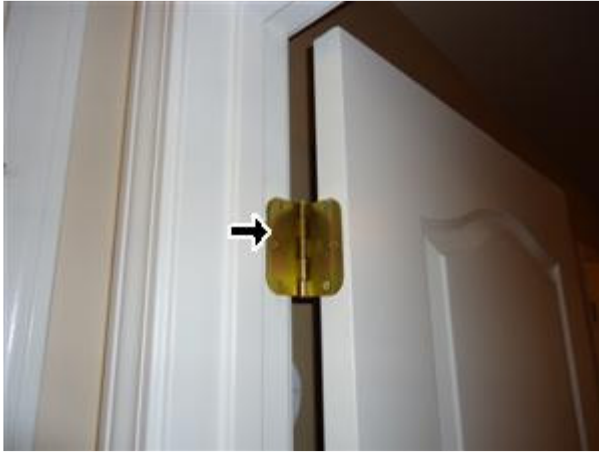
8.5 Picture 3

(2) Interior door at guest bedroom did not shut properly. Some repairs/adjustment to the door may be needed. Recommend repair by a qualified contractor.

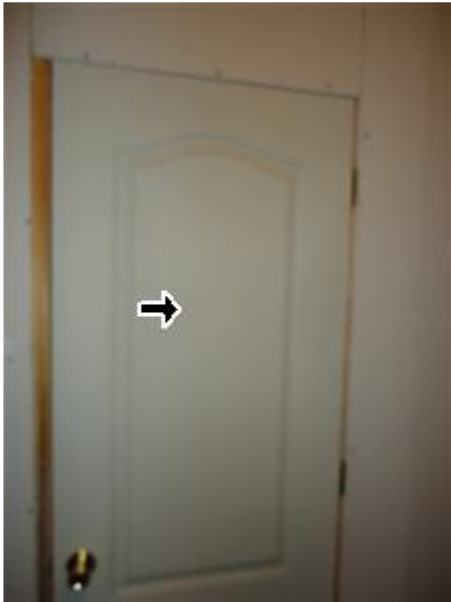
8.5 Picture 4

(3) Interior door at basement show signs of a wood destroying organism present. This is a potential health concern that needs further investigation. Recommend a certified mold remediation company for repairs.

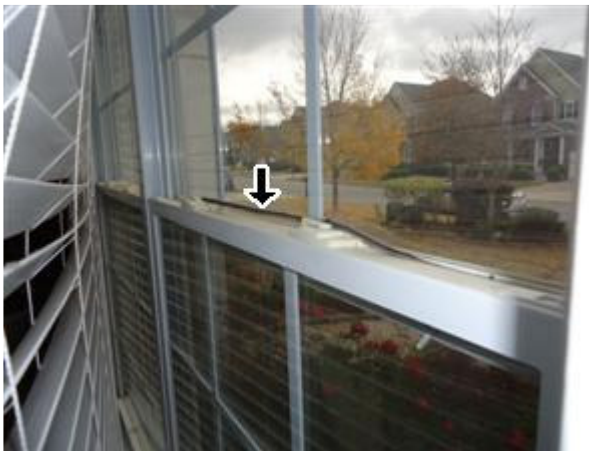
8.6 Picture 1

One window unit seal is damaged at dining room. This can affect your heating, and cooling efficiency. Recommend repair by a qualified contractor.

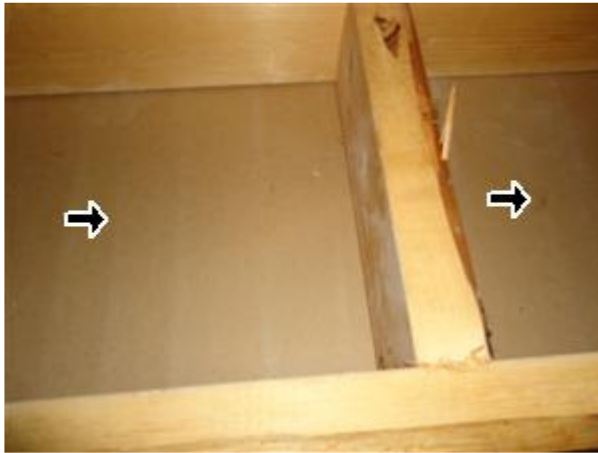
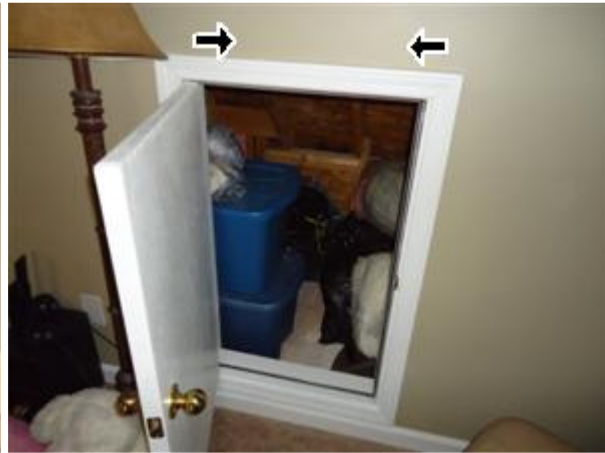
Insulation is missing at some areas where 3 attic door accesses are located. This can cause heating, and cooling loss if not corrected. Recommend repair by a qualified person.

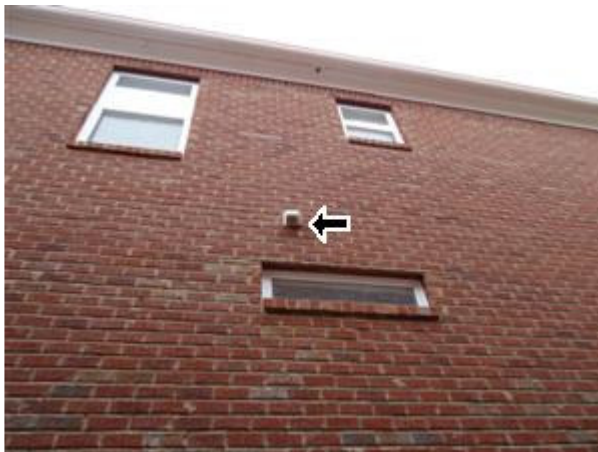
9.2 Picture 1

(1) Exhaust vent at right side of home facing front is not secured properly. Further damage can occur if not corrected. Recommend repair by a qualified contractor.

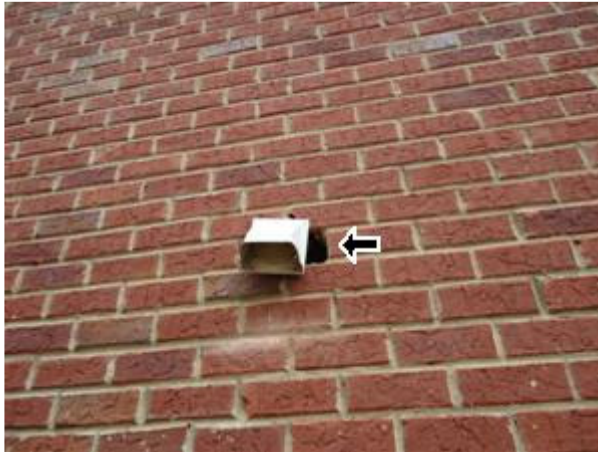
9.2 Picture 2

(2) Exhaust vent at left side of home facing front is not secured properly. I was also unable to determine why this vent

was added. Further damage can occur from moisture entering the home if not corrected. Recommend repair by a qualified contractor.

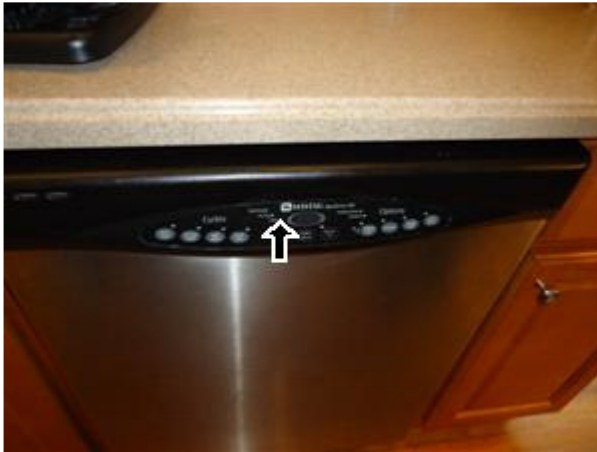
10.0 Picture 1

Dishwasher latch was broken at the time of inspection. I did not inspect this item due to this issue. Recommend repair by a qualified appliance repair company.
