Inspection Report

Property Address:
12712 Waterside Drive
Alpharetta, GA 30004

Atlanta Home Inspections

Date: 11/12/2012	Time: 10:30 AM	Report ID: sample111212
Property: 12712 Waterside Drive Alpharetta, GA 30004	Customer: Sampath Sample	Real Estate Professional:

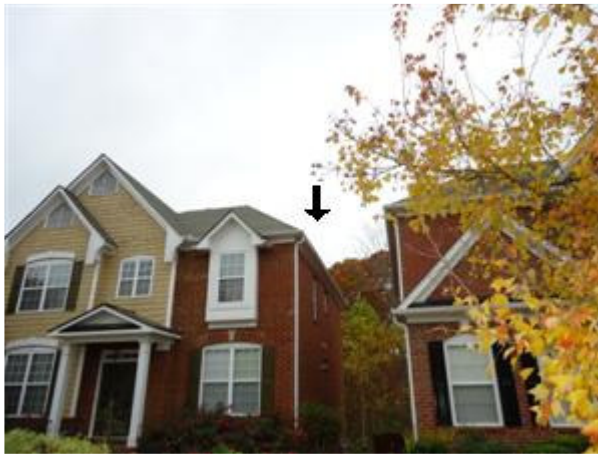
3.0 Picture 5

(3) Due to the close proximity of the other homes I was not able to view this side of the roof. I did not inspect this area.

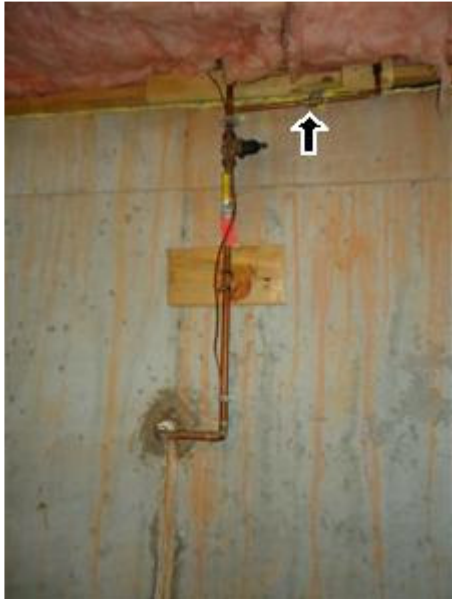
4.3 Picture 1

The main water shut off is located at basement. This is for your information.

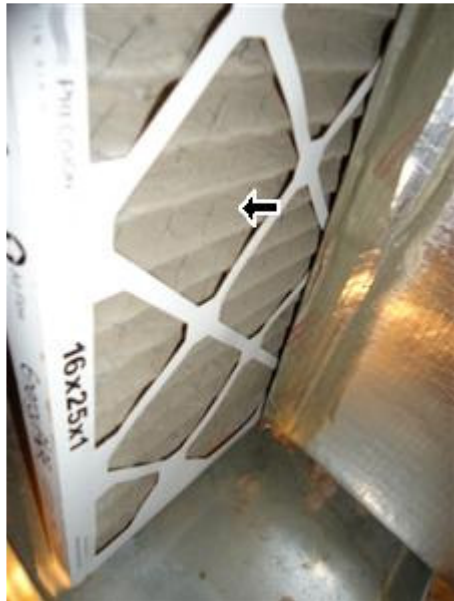
6.5 Picture 1

The HVAC filters are dirty, and need replacing in attic. Clogged filters can affect the efficiency of these units.

Recommend replace by a qualified person.

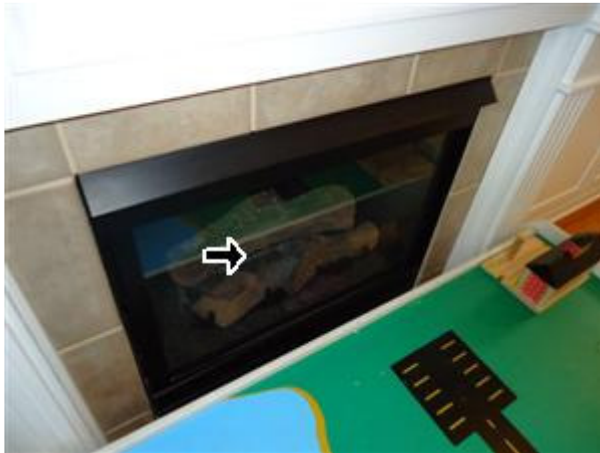
6.6 Picture 1

Pilot light for gas logs was not on at the time of inspection. I was not able to inspect this item.
